CANADIAN FORCES FLIGHT SAFETY INVESTIGATION REPORT (FSIR)

FINAL

1010-130311 (DFS 2-3-2) 7 Sep 2007

AIRCRAFT TYPE: DATE/TIME: LOCATION: CATEGORY: CC130 Hercules 251400Z April 2006 CFS Alert, Nunavut 'D' Category Incident

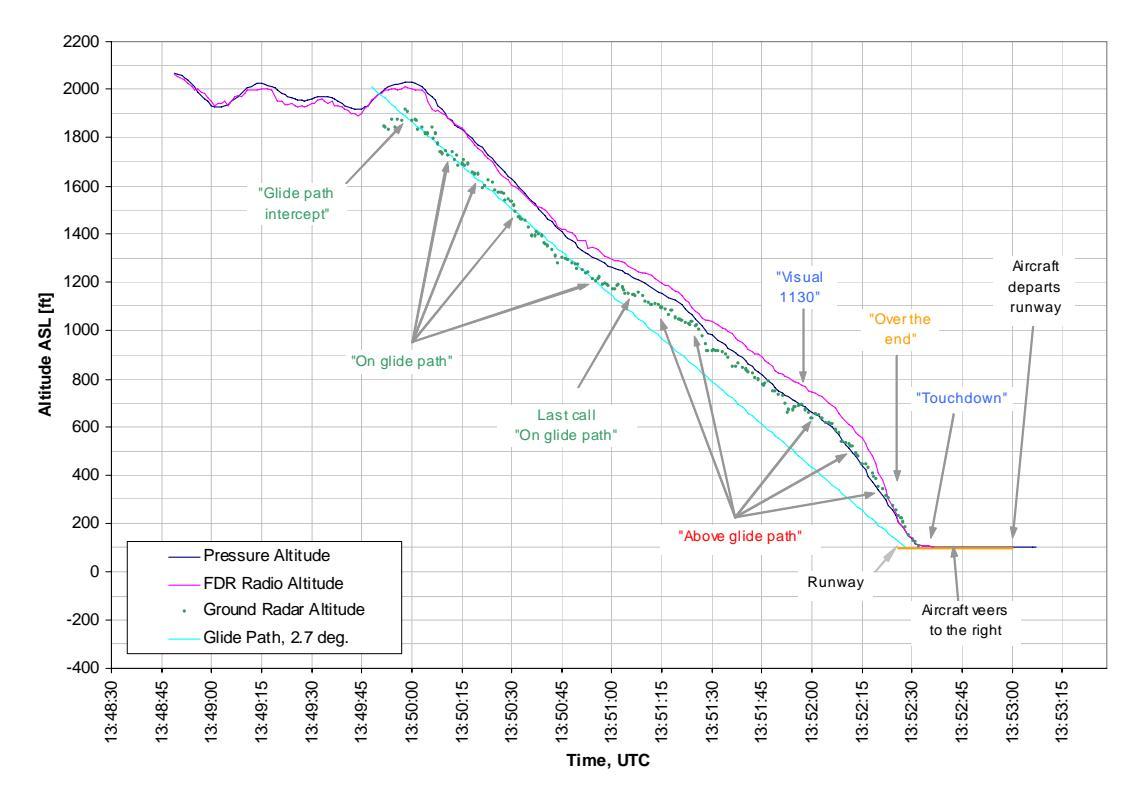
FIGURE 1: Events Overview

regain the G/P; however, it crossed the threshold 75 feet higher and 9 KIAS faster than the targeted values. Figure 1 presents an overview of these events.

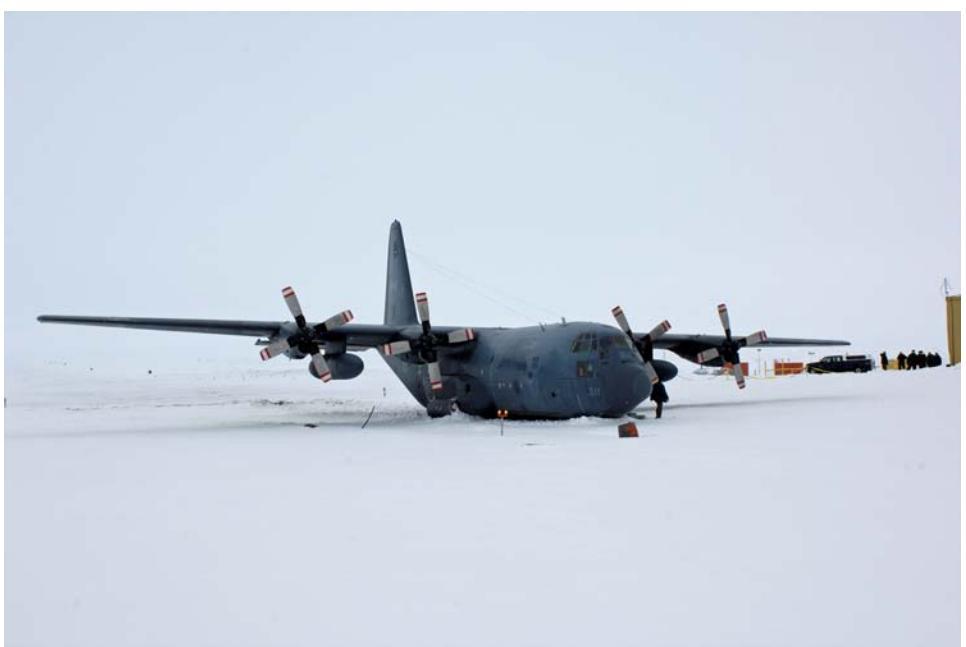
The incident occurred during the landing phase of a resupply mission to Canadian Forces Station (CFS) Alert in support of Op BOXTOP. Upon completion of a precision radar approach (PAR), the aircraft landed long and after touchdown experienced directional control difficulties. The aircraft was unable to stop in the remaining runway available and departed the end, coming to rest in two-foot deep snow. There were no injuries. The aircraft sustained minor damage.

The aircraft sustained minor damage (dents and scrapes) to the forward and aft nose wheel doors and external fuselage skin aft of the nose wheel. As a precaution, maintenance personnel from 8 Wing Trenton were dispatched to Alert to conduct non-destructive testing on the nose wheel oleo trunnion. No faults were found. The damaged nose wheel doors were removed and the aircraft was flown to Trenton under an operational restriction.

Photo 1: Runway departure

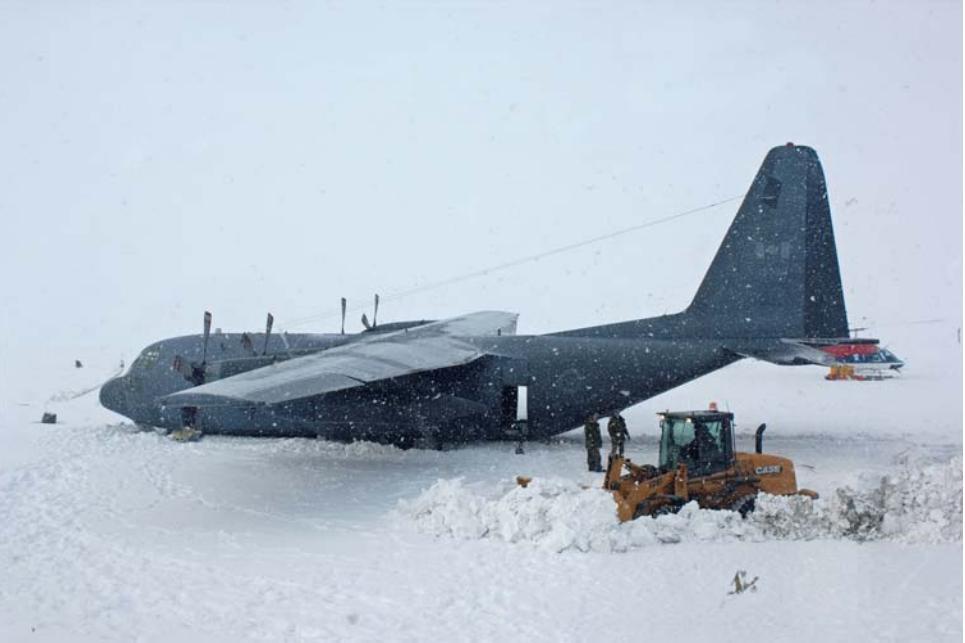
Emergency response personnel secured the site. The runway was closed and the Operation was suspended. Once the minor nature of the damage was ascertained by maintenance personnel, the aircraft was dislodged from the snow with the use of heavy equipment and tow bridles (Annex A, Photo 2). The runway was subsequently re-opened and the Operation resumed.

Photo 2: Commencement of extraction efforts
